## LANDSLIDES AND RELATED FEATURES

OF THE CLYMER, PA. QUADRANGLE

John S. Pomeroy 1979

OPEN FILE MAP 79-1314 (f-8)

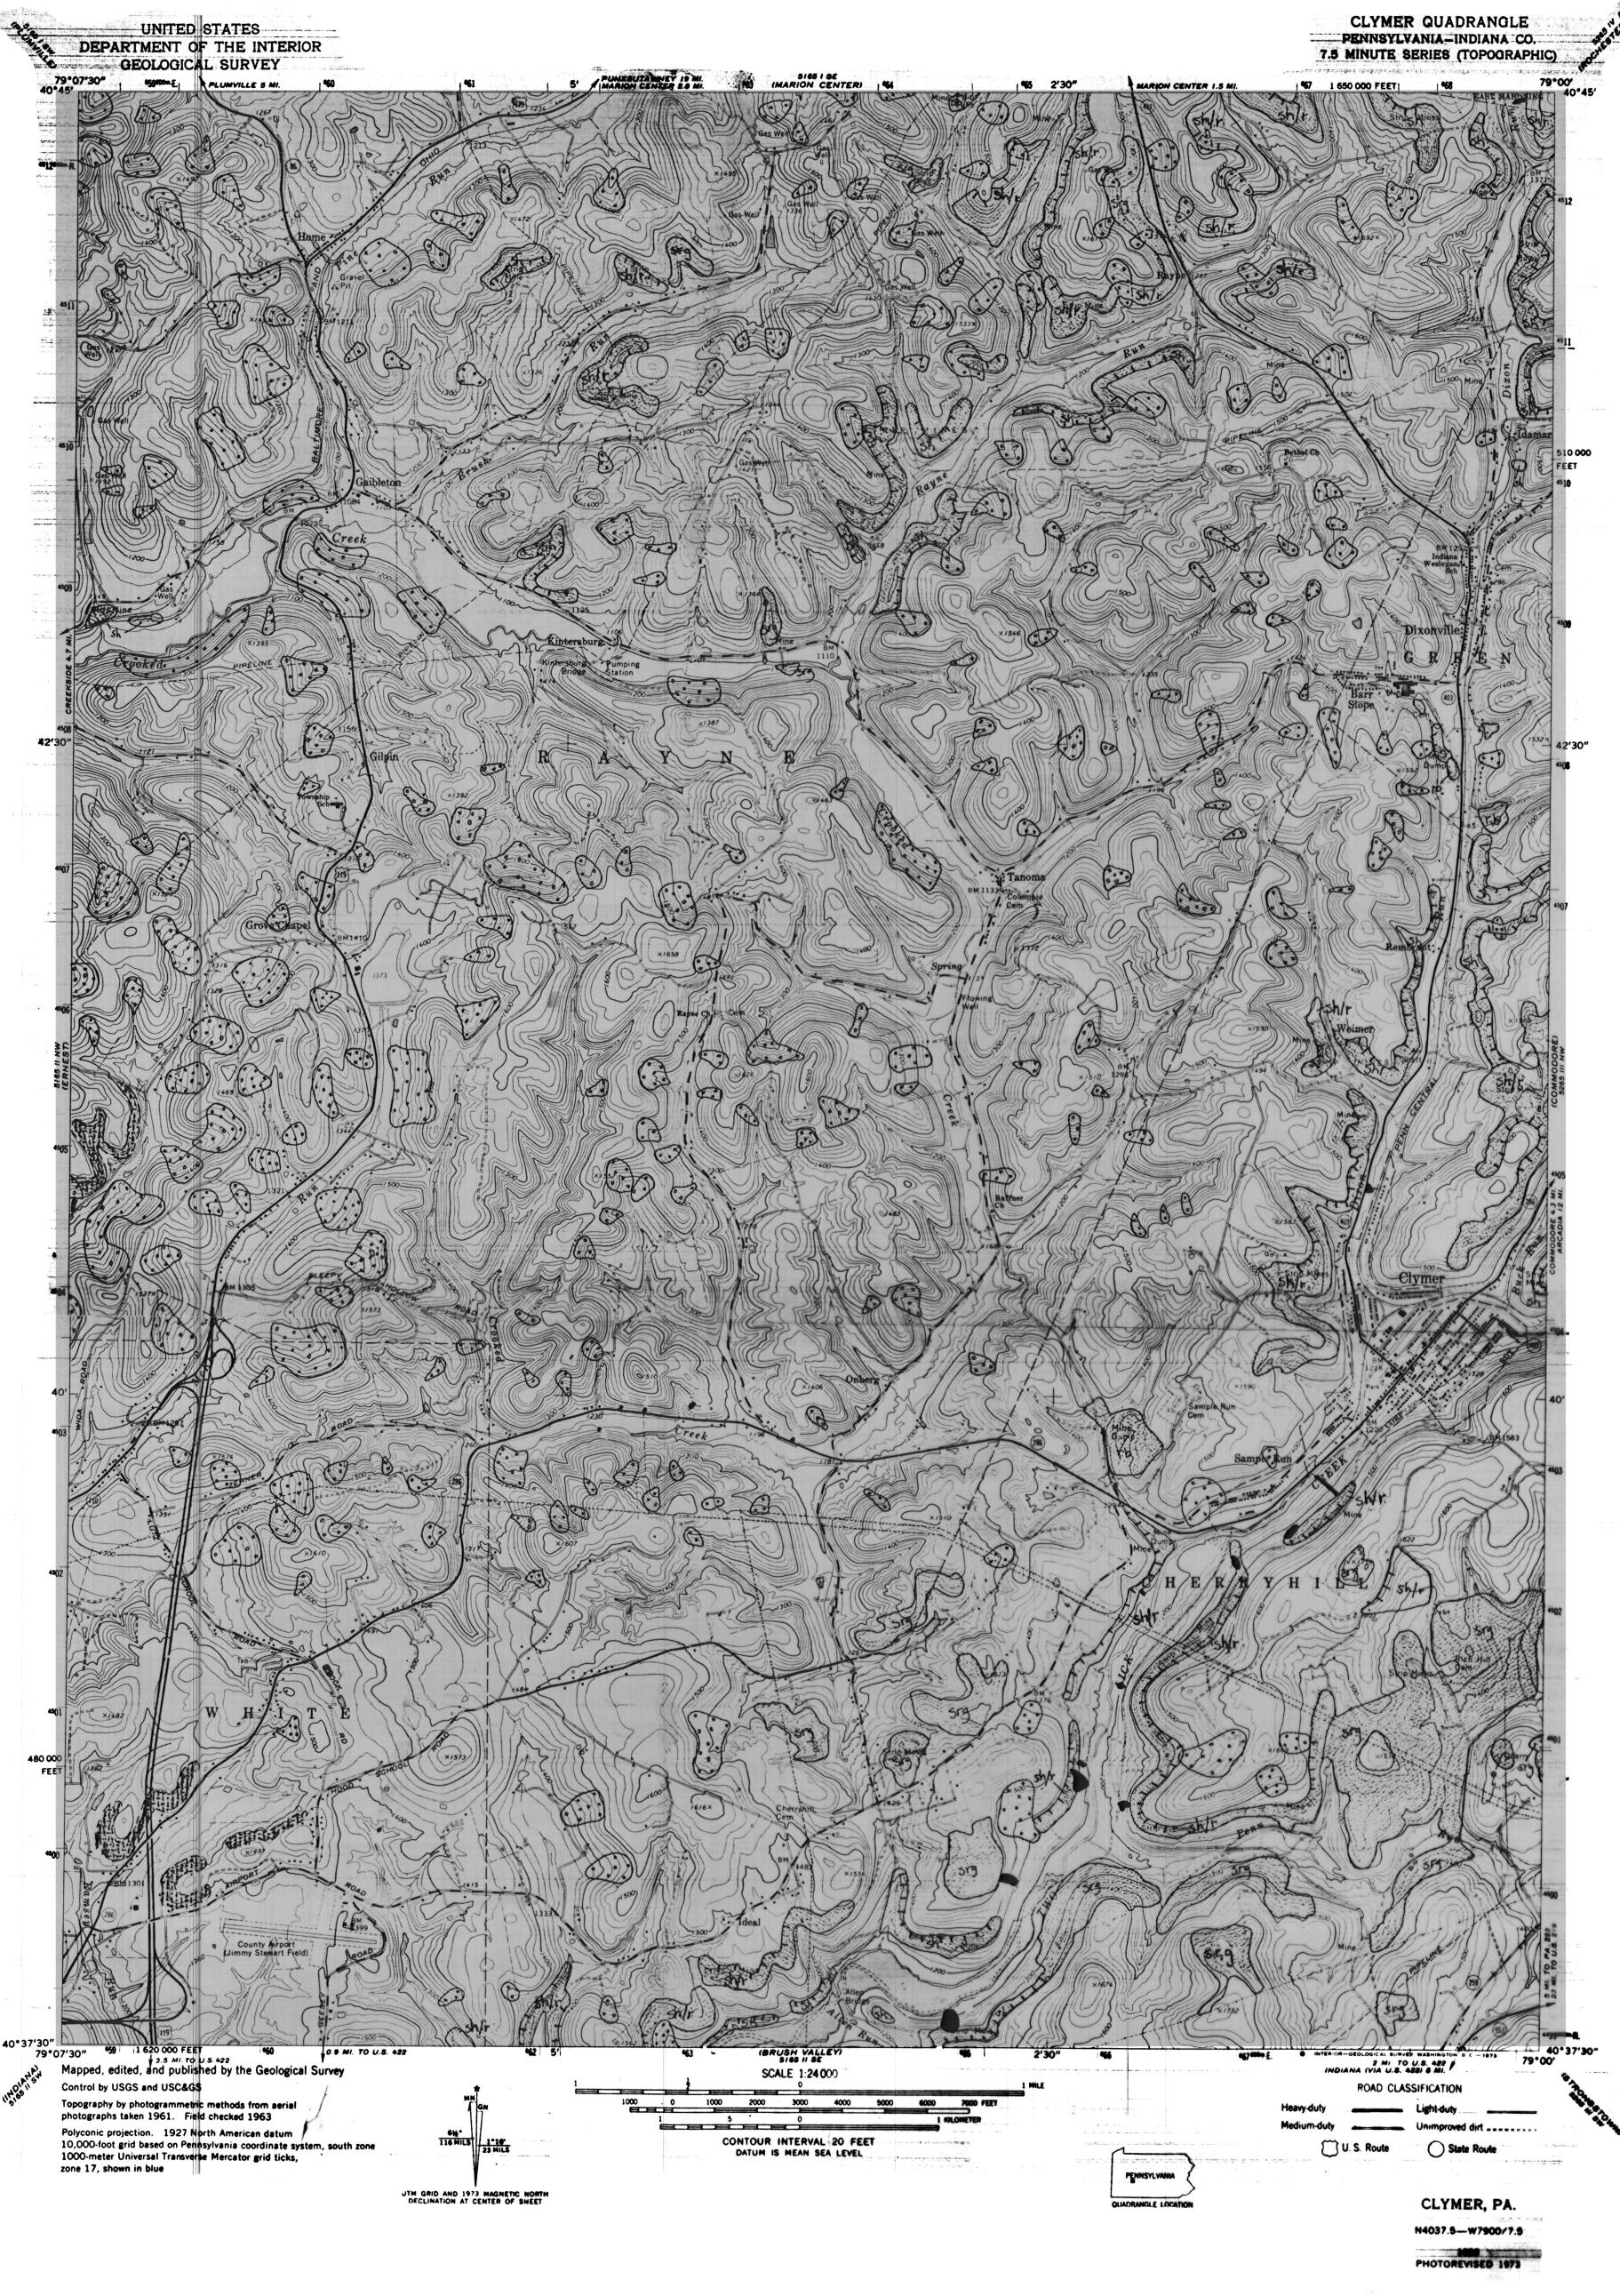
Landslides and related features interpreted from aerial photographs: 1:78,000 (black and white) | 1977

Photointerpretation and field check 1976 This map has not been edited or reviewed for conformity with Geological Survey standards and nomenclature.
